Manhole Inspection Summary

Manhole # S25GG_067MH

Insp Date: **9/5/08 12:02 PM**

Location Address: **ROBERT ST**

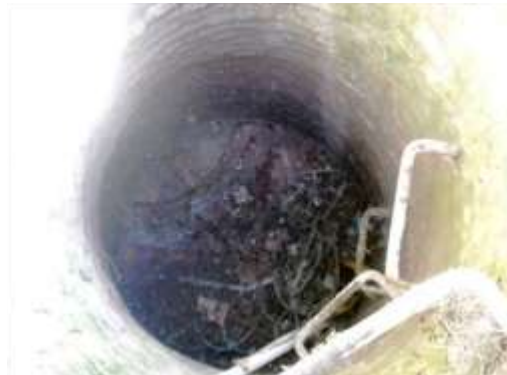
Top View

Barrel infiltration. Evidence of surcharge - Bench debris. Channel debris.

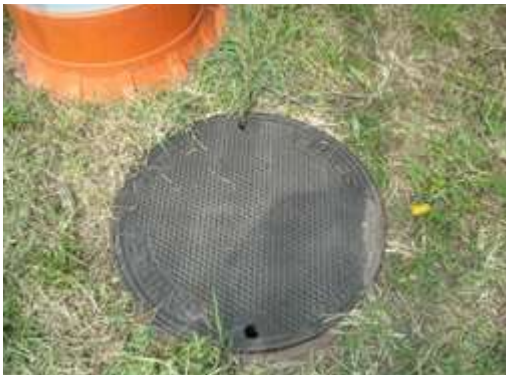
Replacement lid

Comments **BROKE & REPLACED COVER TO COMPLETE INSPECTION.**

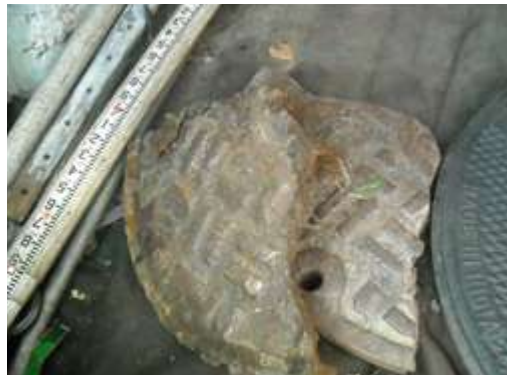
Broken lid

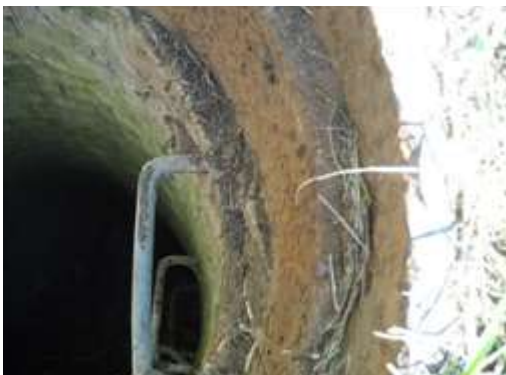
Defect

Frame offset. Corbel infiltration.

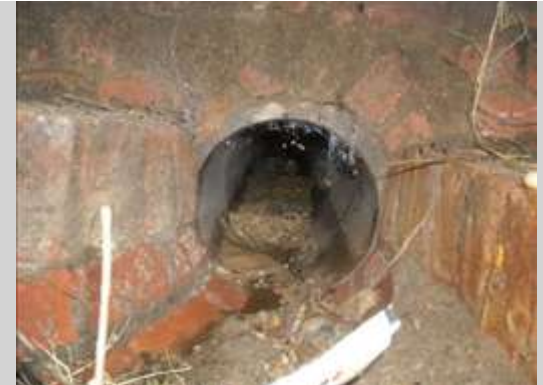
8 in. Circular Gravity Sewer Pipe Out @ 12 O'Clock

Deposits: ☐ None ☒ **Mud** ☐ Sludge ☐ **Debris** ☐ Grease

Silt Depth: **1** (in.) Deposits Extent: **Light**

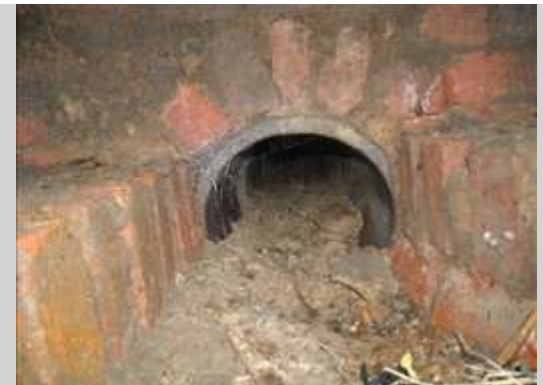
8 in. Circular Gravity Sewer Pipe In @ 9 O'Clock

Deposits: ☐ None ☒ **Mud** ☐ Sludge ☒ **Debris** ☐ Grease

Silt Depth: **3** (in.) Deposits Extent: **Medium**
